CASE HISTORY ~ CH-032

BIO-DUR 560 REPAIRS “BATHTUB RING” AT HANFORD

PRODUCT: BIO-DUR 560

LOCATION: HANFORD, WA

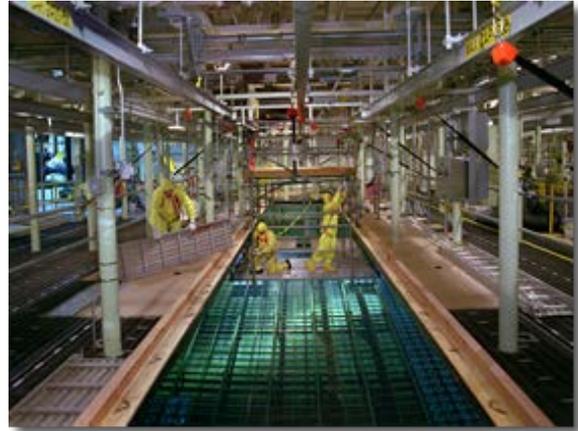
THE CHALLENGE: A spent fuel storage tank in the “K” Basin at the Hanford site, Washington suffered from serious radiologic contamination around the waterline. Over many years the spent fuel containers had allowed their radioactive contents to enter the shielding water and radioactive contamination had precipitated at the waterline to contaminate the concrete tank wall. Personnel walking above the pool were being exposed to unnecessarily high levels of radiation from the concentrated isotopes at the surface.

THE SOLUTION: A nominal ¼” thickness of contaminated concrete was removed from approximately 9” above and below the waterline for disposal. BIO-DUR 560 was then applied using a robotic application system to seal the waterline area against further contamination.

RESULT: The forgiving BIO-DUR 560 formulation assisted the application crew to achieve all desired criteria resulting in a smooth, adherent and abrasion resistant coating around the “K” Basin waterline.
