CASE HISTORY ~ CH-050

BIO-GARD 257 SEALS AND PROTECTS CONCRETE DAM SURFACES AGAINST FROST AND LEAKAGE

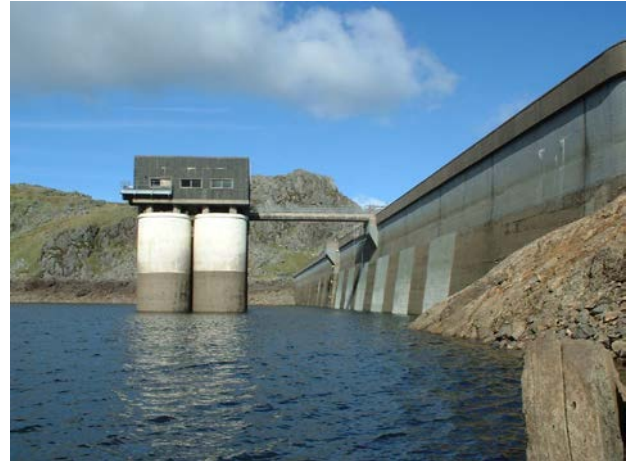
BIO-GARD 257 was applied by roller in two coats over the actual dry pour joints extending about 26 feet (8 meters) on either side to a depth of 80 feet (24 meters). The first coat of mauve-tinted coating was easily applied onto the running wet concrete surface immediately after preparation by hydro blasting. After 4 – 24 hours, a second coat of gray-tinted material was applied.

Applications were made from a hanging scaffold that followed the water level as it fell throughout the day. Water blasters, operating at approximately 5000 psi, were effective in removing algae and other surface contamination. This resulted in a wet, but otherwise clean surface. The BIO-GARD 257 coating with a pot life in excess of 45 minutes, was applied with no problem directly to the surface using rollers, and it cured to a "firm" condition in about 5 hours.

THE RESULT: The application by roller directly onto running wet concrete was completely without problems. The BIO-GARD 257 cured well overnight, even when underwater, and has formed a tough, tightly adherent coating which has given many years of protection to the irreplaceable dam structure.
