A New Face on an Old Problem

By O. P. Williams,
First Hydro Co., Wales, UK

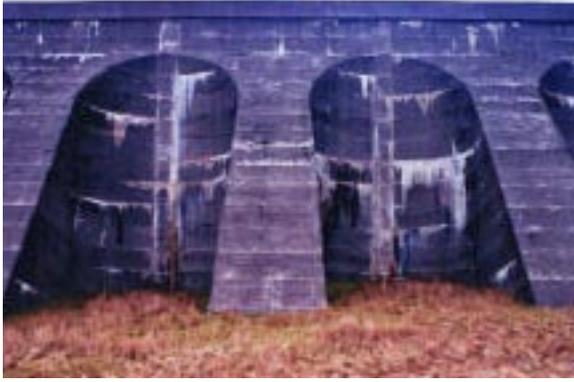
Left: Efflorescence and subsequent spalling on the Stwlan Dam
Below: General view of the dam
Photos courtesy of the author

Like many mass concrete structures of its age, Stwlan’s downstream face became streaked with efflorescence soon after completion. What became called the “stale-bread” effect was due to a combination of too much cement content and overly slow rates of construction. This combination created high differential temperatures during early curing, which resulted in slightly un-bonded lift lines. Water seepage through the dam walls reacted with free lime and slowly sealed almost all the leakage.

Stwlan also had an unusual double-wedge contraction joint between its buttresses. These joints were generally never quite sealed, and seepage continued, freezing and thawing winter after winter, until eventually, fragments of concrete began to spall and fall off. The ground between the buttresses had then to be fenced off to protect the public and grazing animals from falling concrete.

Sealing the more accessible downstream face of the dam was rejected; water would continue to enter the structure, and repairs were likely to fail under the high and cyclical water pressure coming from the reservoir. So the less accessible upstream face would be sealed.

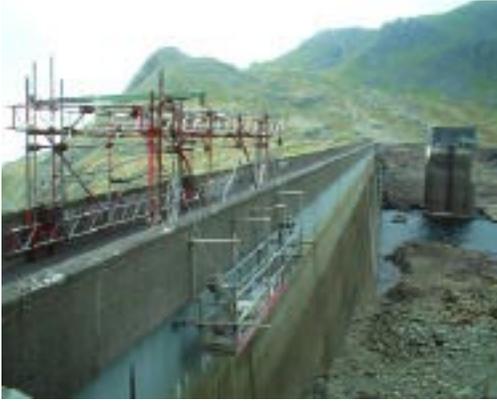
Access platform suspended from special mobile rig on the dam crest for second round of coating trials

contractor, formerly Palmers but now Pyeroy of Rosyth and Newcastle, then applied the three best coatings from an access platform suspended from a special mobile rig on the dam crest road.

Each product was applied in a 4-metre-wide strip the full height of a double buttress joint, each under the direction and supervision of the coating manufacturer.
