CASE HISTORY ~ CH-042

PRODUCT: BIO-FLOR 182

**BIO-FLOR 182 SEAMLESS EPOXY FLOORING/VINYL CHIP SYSTEM
CREATES AN ATTRACTIVE FLOOR ON OLD AND CRACKED CONCRETE**

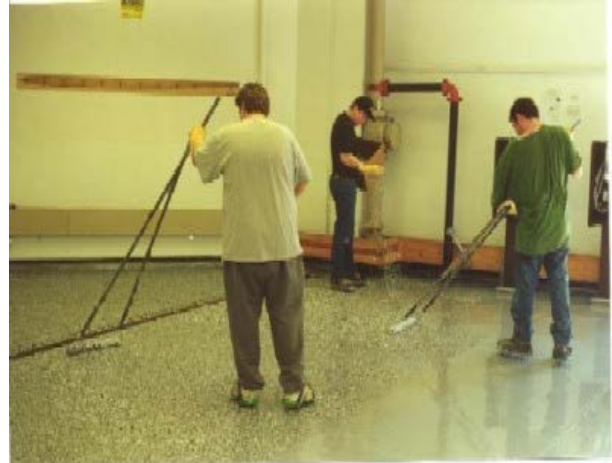
The BIO-FLOR™ base coat was allowed to cure for approximately 4 hours before a full application of BIO-FLOR™ 182 clear coat was applied. Immediately after this application the custom blended black and white color-chips were broadcast by “chicken-feeding” by hand. Gently lofting the chips into the air allows them to disperse and settle evenly without clumps. When sufficient chips have been broadcast to almost cover the surface they are “backrolled” into the fresh BIO-FLOR™ clear coat using the same roller used for the initial application.

This broadcasting aims at allowing some of the underlying base coat to remain exposed. To all appearances this visible base coat of gray appears as other color chips alongside the black and white of the broadcast.
