CASE HISTORY ~ CH-044

BIO-GARD 257 SEALS AND PROTECTS CONCRETE DAM SURFACES AGAINST FROST AND LEAKAGE

CH-43 FOLLOW UP

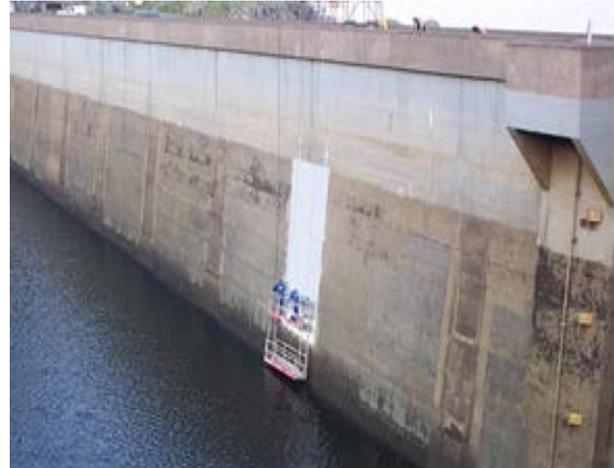
employed in the full-scale coating. The two-tiered scaffold shown was used to provide close and safe access to the dam face.

Water jetting using about 5,000 psi yielded a clean surface with excellent productivity. A two-coat system was planned, with a white base coat being the first applied followed by the Haze Gray finish coat shown above each being applied at a nominal 100 sq.ft./gallon to yield 16 mils per coat.

RESULT: Application by roller directly on to running wet concrete was completely without problems. The BIO-GARD 257 coats cured well overnight even when underwater and have formed a tough, tightly adherent coating which will give many years of protection to the irreplaceable dam structure.
