CASE HISTORY ~ CH-061

TOWER-GARD 568 PROTECTS URBAN MICROWAVE TRANSMISSION TOWER

PRODUCT: TOWER-GARD 568 YEAR: 2013 LOCATION: ENGLAND

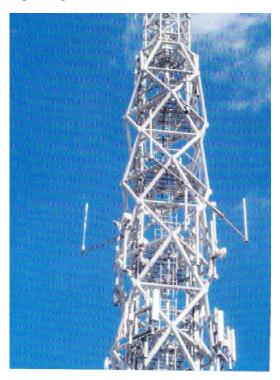
RESULT: The complexity of the application can be appreciated from the image below. The tower is now protected against corrosion and looks aesthetically much more pleasing:

THE SOLUTION TOWER-GARD 568 was especially formulated to provide a solution in which single heavy coating, tolerant of compromised surface preparation, would provide good long-term protection to bare steel, previously painted surfaces and worn galvanized surfaces.

Surface tolerance to wet conditions during application and curing was important because the application had to take place at night in typical English weather. All coating was applied by brush or roller, often over wet surfaces. Surface preparation was less than optimal because of poor illumination and difficult access.
