CASE HISTORY ~ CH-028

BIO-DECK 190 RESTORES TOWVEYOR TRACKS IN BUSY MATERIALS HANDLING FACILITY

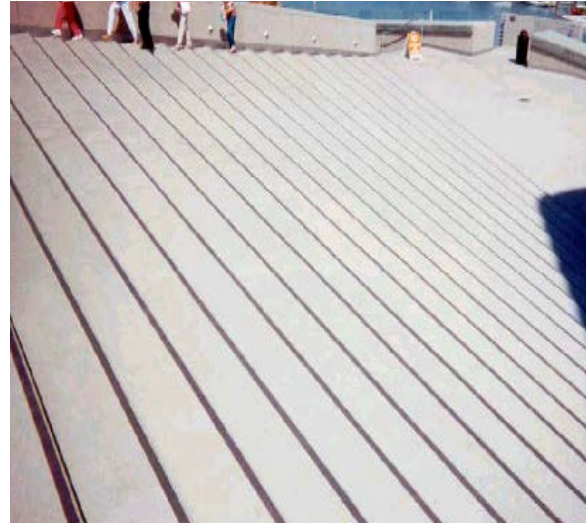
The installation crew mobilized on site in advance of the agreed start time and commenced surface preparation as soon as the Towveyor® system was shut down. Pneumatic chisels were used to remove failed cementitious topping and oversized aggregate in the 10” wide tracks. After this the tracks were abrasive blasted using Blastrac® equipment.

The BIO-DECK 190 is supplied in a “kit” of blended aggregates, epoxy resin and curing agent all contained within a 5-gallon pail. Blending all ingredients within this pail using a ½” “Jiffy” style mixer makes a just-pourable repair material. The mixed material was poured into the prepared track and roughly spread out – natural self-leveling then took over to make a smooth surface. No further attention was required after installation and the repair was cured sufficiently for unrestricted use within four (4) hours.
