CASE HISTORY ~ CH-039

BIO-FLOR 182 CREATES A MILE OF CUSTOM SAFETY NOSING FOR MUSEUM OF GLASS STEPS

PRODUCT: BIO-FLOR 182

LOCATION: TACOMA, WA

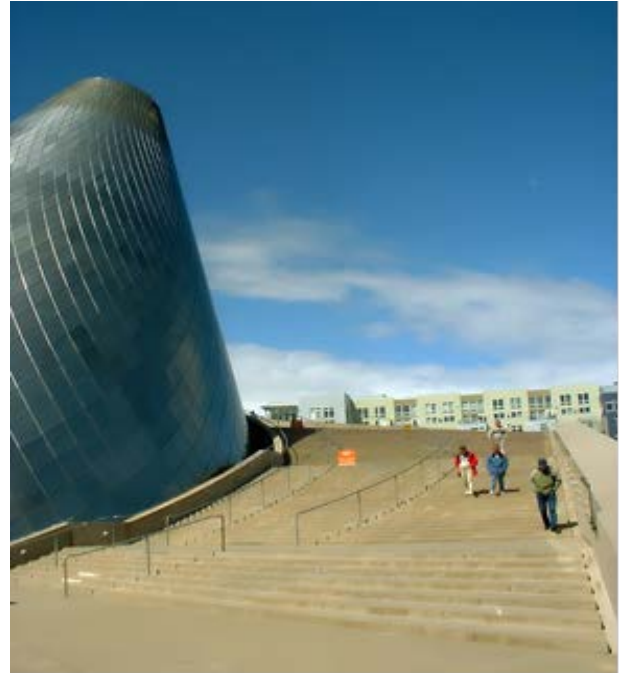
THE CHALLENGE: The “Museum of Glass” is located in Tacoma, Washington. This impressive facility is situated high above a scenic waterway and is approached by a series of massive stone stairs with a total length of 5,600 lineal feet. In rainy weather the nosing of these steps was too slippery for safety and measures had to be taken to improve their slip resistance.

The contractor noted that the concrete on the steps was “open” and porous, not heavily troweled. Examination showed there to be no weak surface laitance layer which would be cause for concern. Initial applications of the BIO-FLOR 182 showed that it tended to creep under masking tape edges to make an unsightly line. To avoid this the BIO-FLOR 182 nosing stripes were taped using duct tape that was sealed at its edge using a latex paint tinted to match the surrounding concrete color.

The BIO-FLOR 182 was applied directly to the dry concrete surface after vigorous sweeping to remove loose dirt. Immediately after this application white, 36 mesh aluminum oxide was broadcast into the wet BIO-FLOR and back rolled to properly incorporate it. Once cured the aluminum oxide was tightly bound into the epoxy film and sufficiently exposed to create an aggressive slip resistant surface.

RESULT: The appearance and slip resistance of these large step surfaces has been greatly improved through the use of BIO-FLOR 182. The quick cure time and complete water tolerance during curing of this material ensured predictable, excellent results and maintenance of a tight production schedule throughout the project.
