CASE HISTORY ~ CH-041

FASTONITE™ 700 RESTORES FAMILY SWIMMING POOL TO “BETTER THAN EVER”

PRODUCT: FST 700

LOCATION: HOUSTON, TX

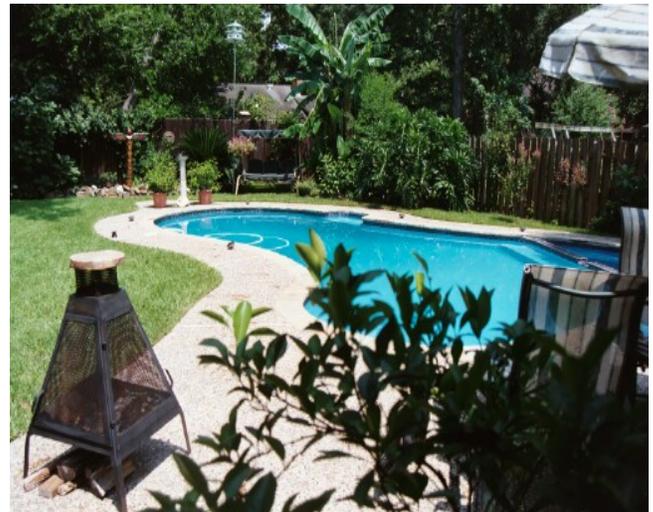
On the second and third days two full coats of FASTONITE™ 700 were applied by roller. The finish color of medium blue shown was selected to attract solar heat ensuring a longer swimming season. Interestingly, the pool does not overheat during the long Texas summer. The probability is that excess heat is radiated from the darker pool each night, being replaced by absorbed heat each day.

RESULT: The pool was transformed from a high maintenance, badly worn eyesore into an attractive, efficient asset. Spherical glass beads were broadcast on the bottom of the shallow end of the pool to provide a firm grip for water sports without risking injuries from abrasion.

The medium blue color is attractive and has proven effective at heating the pool earlier in the swimming season as well as retaining swimming temperature until later in the year. Chemical use is approximately halved and algae growth is now non-existent.

THE SOLUTION: Over the course of a three-day weekend two workmen drained the pool, repaired damaged plaster and applied two coats of FASTONITE™700 pool lining.

During the first day the pool was thoroughly water-jetted after draining using a 3,000psi gas powered unit. The surface was in such poor condition that this treatment removed a substantial top layer plus small patches of disintegrating plaster. A full coat of White BIO-SEAL™ 192 was applied by roller to seal and reinforce the plaster surface when the pool had dried after a final rinse with fresh water.

“Divots” of missing plaster were filled in with BIO-DUR™ 561 applied by a straight edged spreader after the BIO-SEAL™ had cured for about 4 hours. Rough areas were ground flat using an electric grinder after the BIO-DUR™ 561 had cured overnight.
