CASE HISTORY ~ CH-031

BIO-DUR 560 EPOXY COATING APPLIED BY HEATED, PLURAL COMPONENT AIRLESS SPRAY TO GAS PIPELINE.

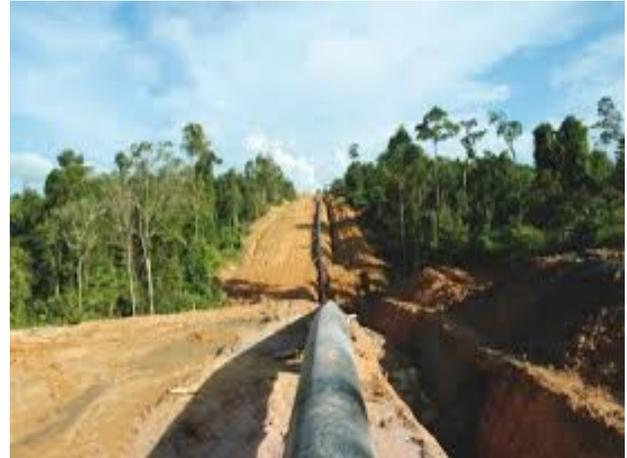
The repair areas were typically about 50' sections of pipe which were excavated then abrasive blasted to White Metal, (SSPC-SP-10, SA3) standard. Immediately after blasting a single coat of BIO-DUR 560 was applied at nominal 22 mils film thickness with an extra pass along all welds and other discontinuities. Thin Film Technology provided a technician for initial start up since the repair crew had never used plural airless spray before. Within a couple of days the applicators were thoroughly familiar with the equipment and turning out extremely professional work. It was

found that the wet film was smooth and impervious at 22 mils, (550 microns), yet could easily be sprayed to over 80 mils, (2,000 microns) without sagging on vertical surfaces. Occasional porosity from, for example, insects, was easily repaired by simple application of fresh BIO-DUR 560 without any additional surface preparation.

In one section a heavy thunderstorm drenched the freshly applied BIO-DUR 560 only minutes after application. When "jeeped" for pinholes at 2,000 volts the next morning only one (1) jeep – caused by an insect in the film – was found in the 50 foot section.
