CASE HISTORY ~ CH-073

CRUDE OIL STORAGE TANK REPAIR USING SINK-NOT 350 FLOTATION FOAM

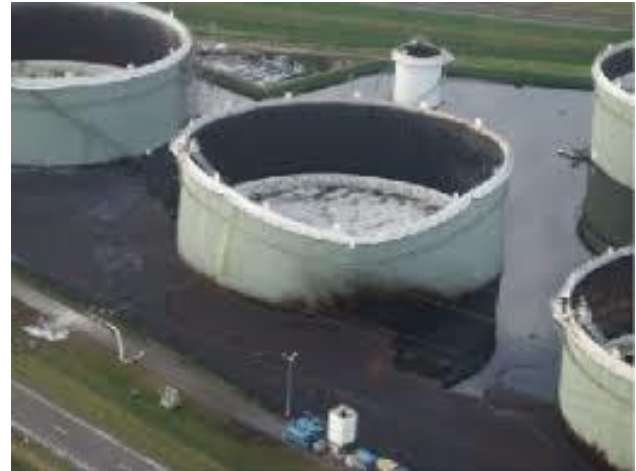
Crude Oil Storage Tank damage from roof collapse.

THE CHALLENGE: Large floating roof storage tanks are often subject to internal corrosion caused by their contents. Crude oil storage tanks in particular are vulnerable to corrosion in the upper spaces caused by moist acidic vapors. Pontoons supporting the roof are particularly at risk because of their light construction and extensive welds. If pontoons fail by flooding, either from product below or rain from above, the whole roof may sink causing extensive tank damage and a long period of time out of service.
